Improvements to the rescue robot Quince

Toward future indoor surveillance missions in the Fukushima Daiichi Nuclear Power Plant

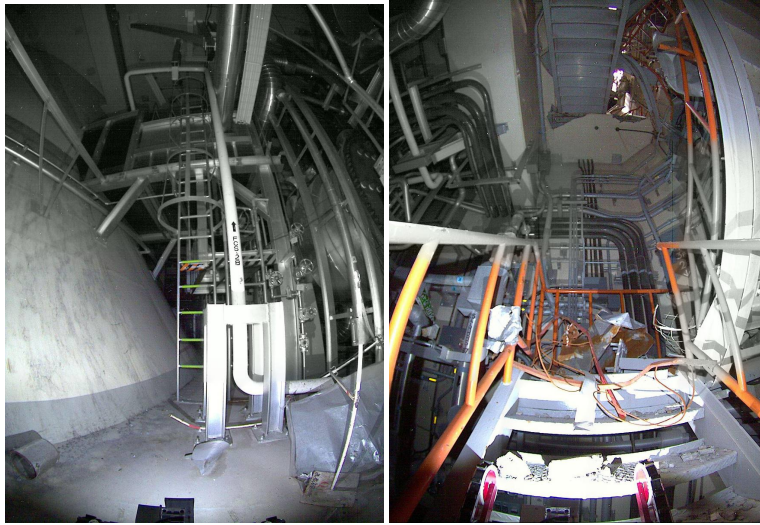
Fig. 1 High-resolution photos captured in the reactor building of unit 3. The left shows the piping of the core spray system and the right shows the rubble blocking the staircase to the third floor.

Fig. 1 shows the high-resolution photographs captured by the wide-angle camera on Quince 1. The left photograph shows the piping of the core spray system, which was located next to the primary containment vessel. The right photograph is of the staircase to the third floor, showing the rubble blocking the staircase.

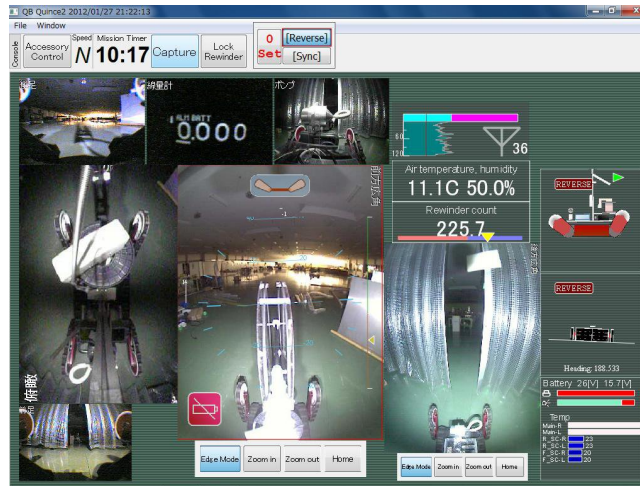
Fig. 7 Improved operator console screen for Quince 2. Status indicators for information such as the amount of cable remaining, temperature, and wireless signal strength, and some alert signals were added.

The new operator console was improved to consider the feedback given by the operators of the missions conducted by Quince 1. Fig. 7 shows the new console screen. The major improvements in response to the feedback were as follows:
